SCHÖNOX | CASE STUDY: MASSEY BUILDING/IBERIA BANK

Project Name: Massey Building - Iberia Bank

Project Location: Birmingham, AL

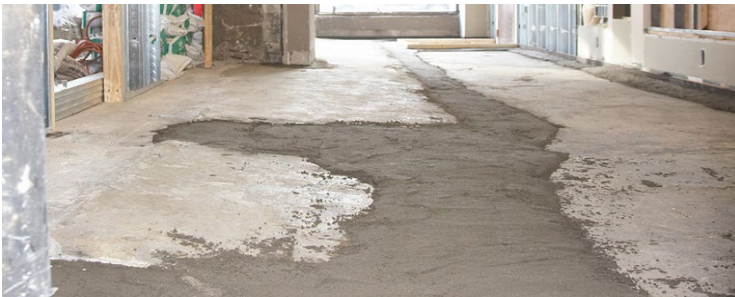
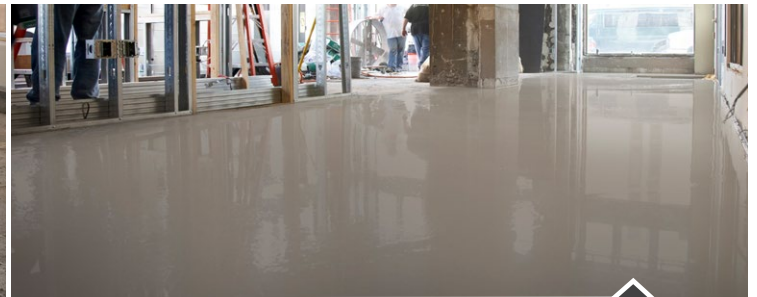
Renovated Subfloor – Going from Here to There

Virtually any floor covering can be installed over Schönox US.
